Pier Luigi Nervi Project Foundation

Torino Esposizioni Conservation plan

CONSERVATION MANAGEMENT PLAN

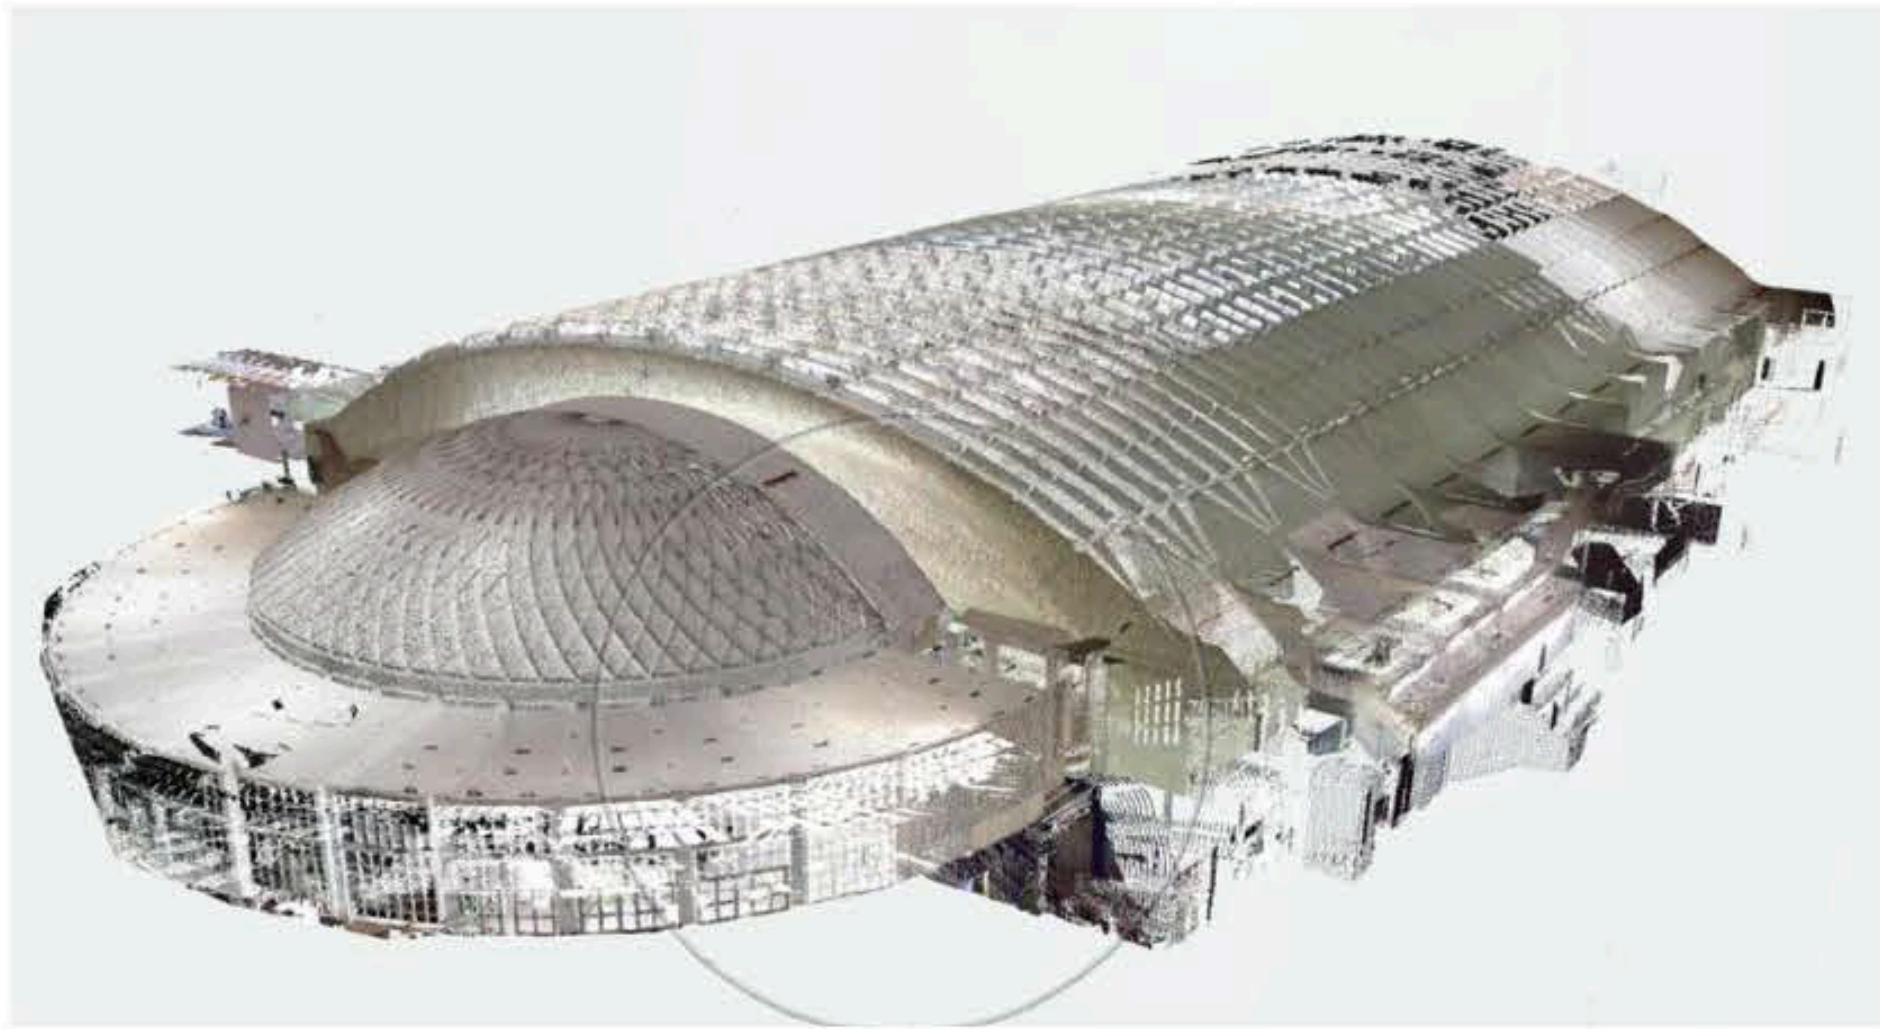
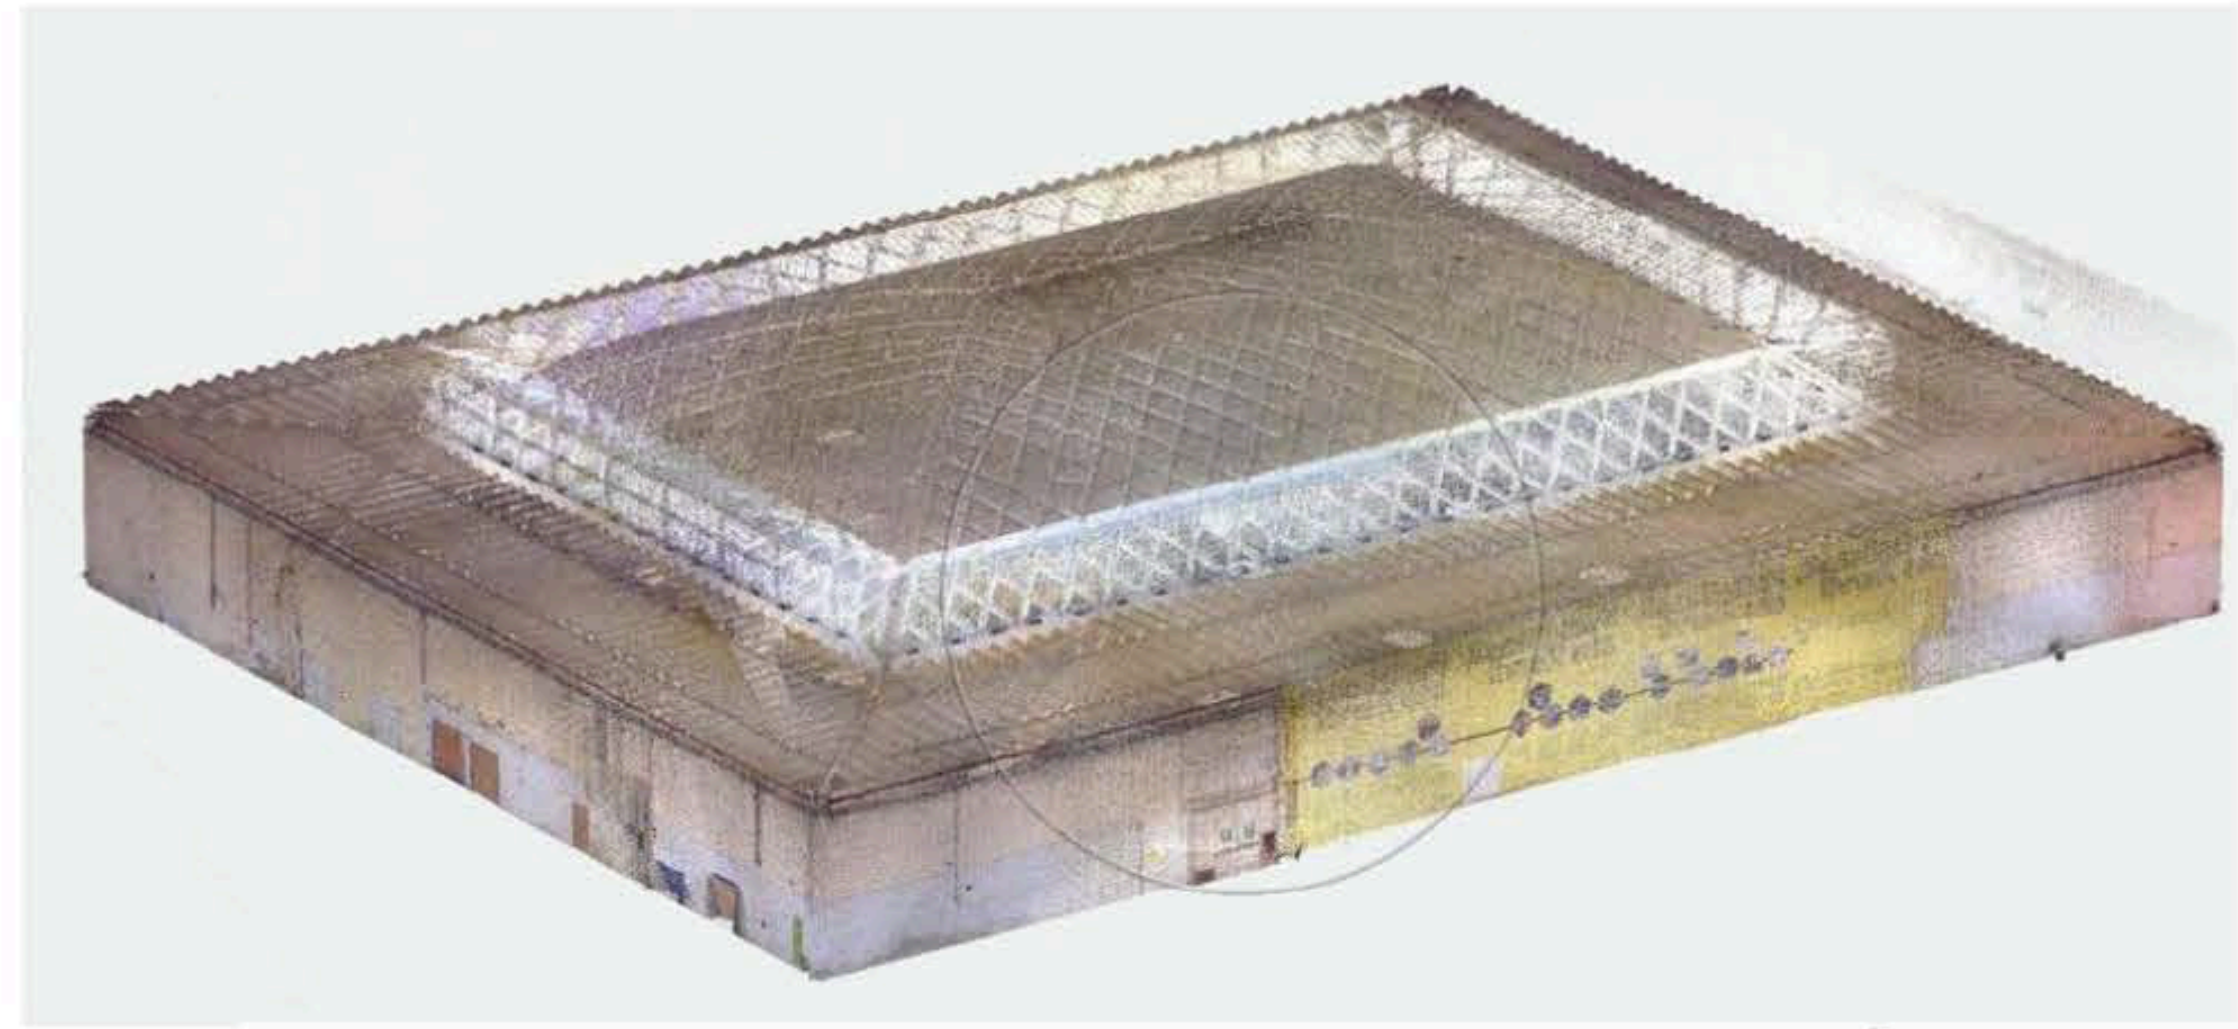
3D METRIC DOCUMENTATION
USING GEOMATIC METHODS

laser-scan e modellazione 3D dello stato attuale, inclusa l'implementazione dell'analisi del **degrado**

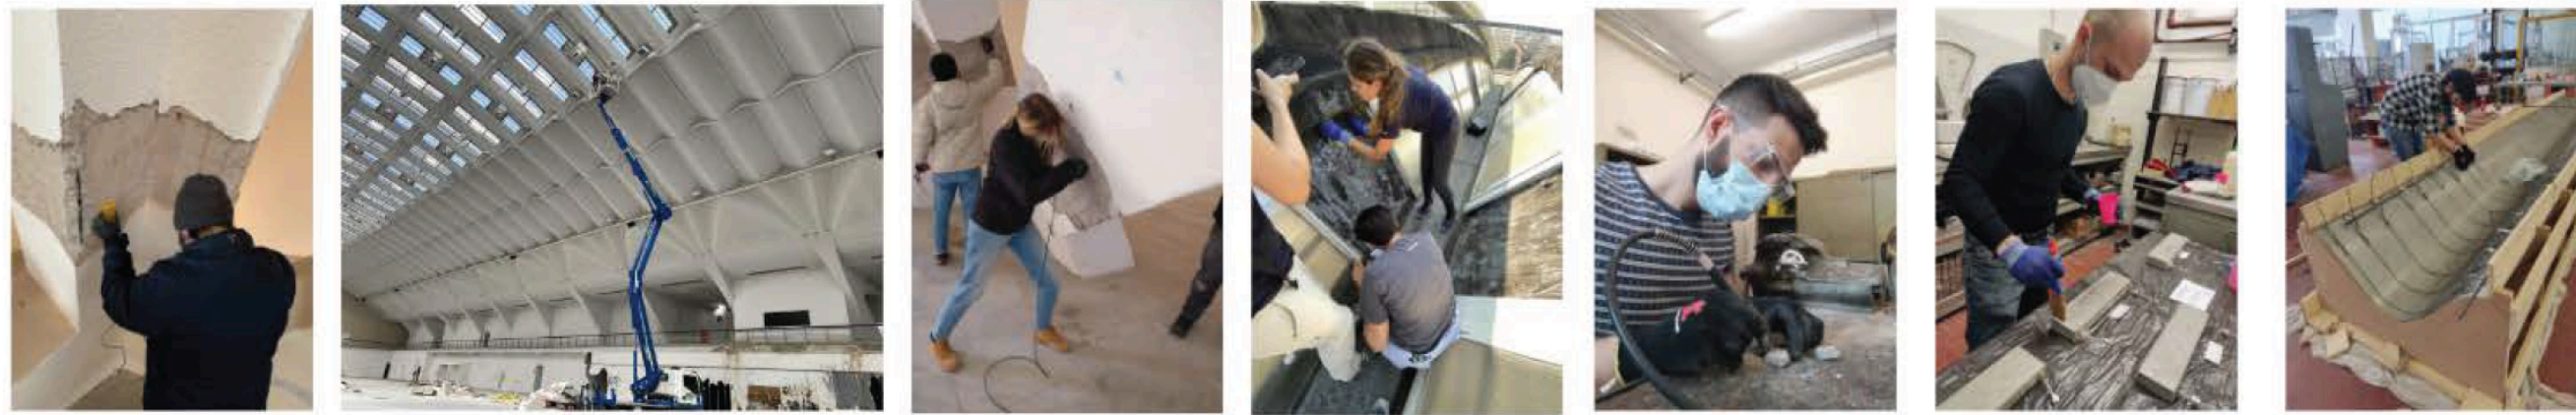
STRUCTURAL, MATERIAL AND SEISMIC ASSESSMENT
FIELD & LABORATORY

svolgimento di una campagna di **indagini** per la valutazione strutturale e dei materiali attraverso diversi metodi di indagine tra cui **carotaggi, prove dinamiche, analisi delle pitture** e la **riproduzione in laboratorio di mockup di ferrocemento** partendo dalla ricetta originale di Nervi.

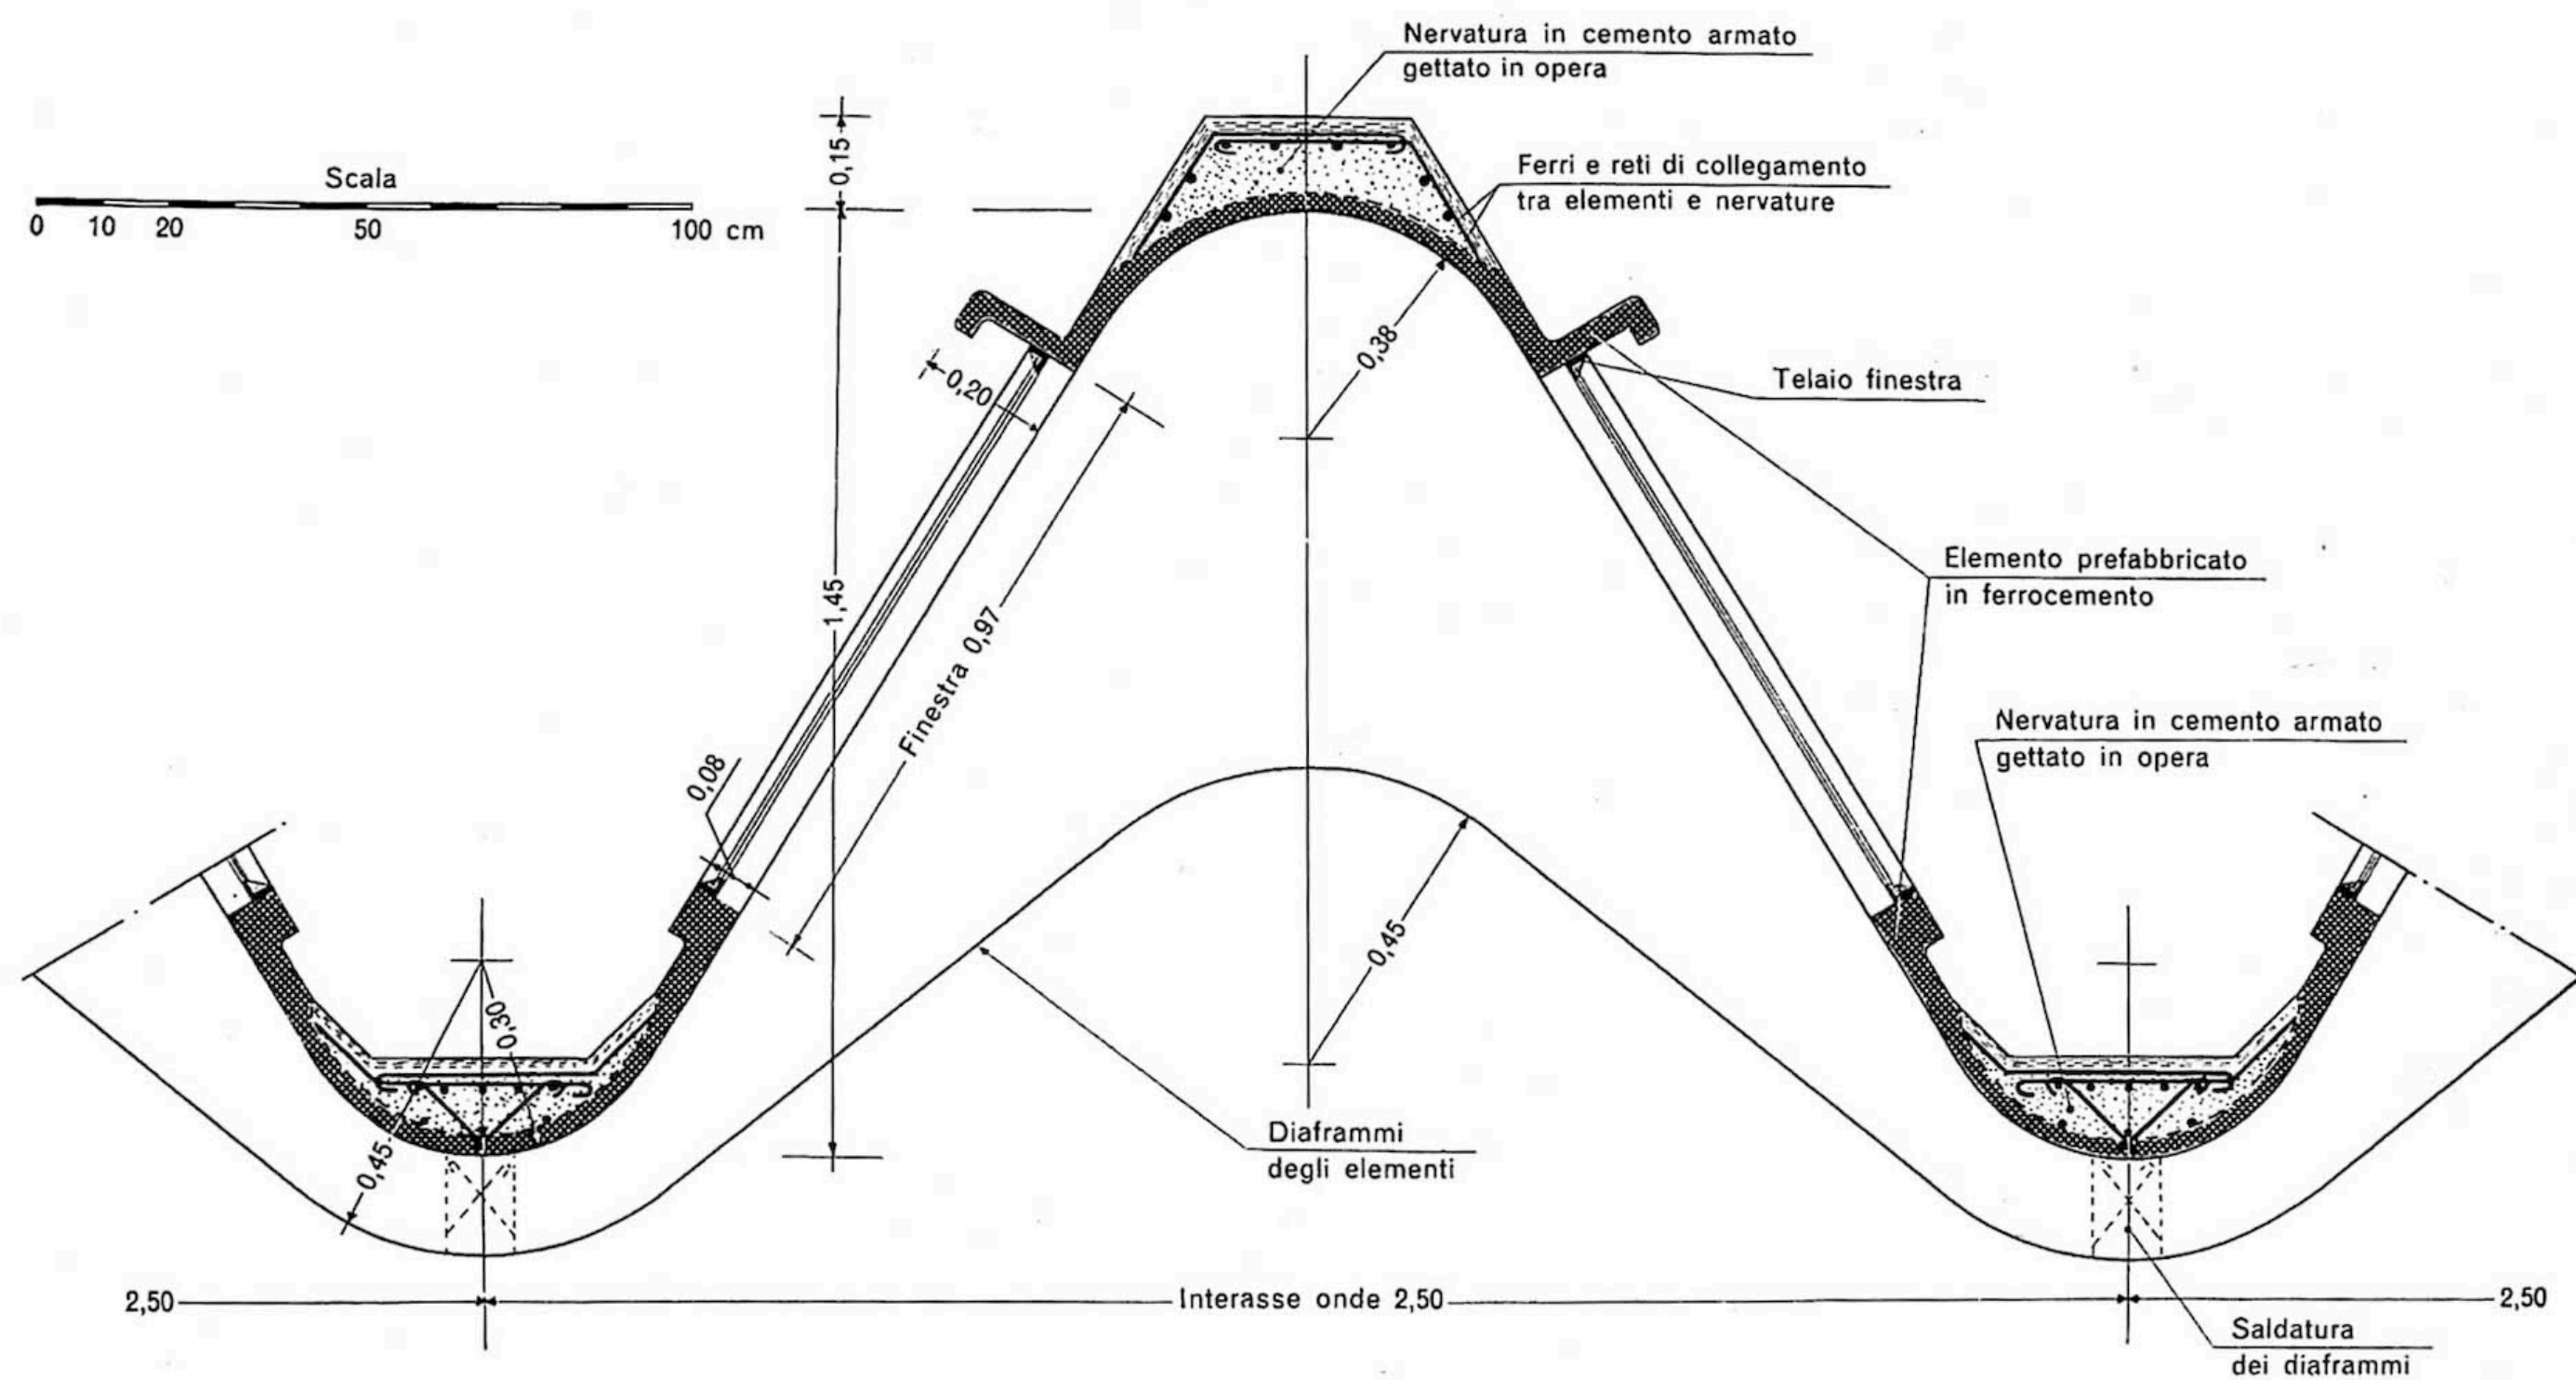
Brevetto n. 445781 (1949): il "concio d'onda". La particolare forma ondulata, facilmente ottenibile con il ferroceemento, consente di sfruttare la resistenza per forma anziché per massa, con conseguenti grandi economie di materiale
